T-215
Langdon; Bridges
7373 Tilghman Island Rd
Tilghman Vicinity
Ca. 1929
Private

Note: This appends the MHT survey form for T-215 written in 1977 for the main residence, Seth Family graveyards, and domestic grounds.

Maryland Inventory of Historic Properties Form

historic Langdon Farm Complex; Bridges
other Hebron

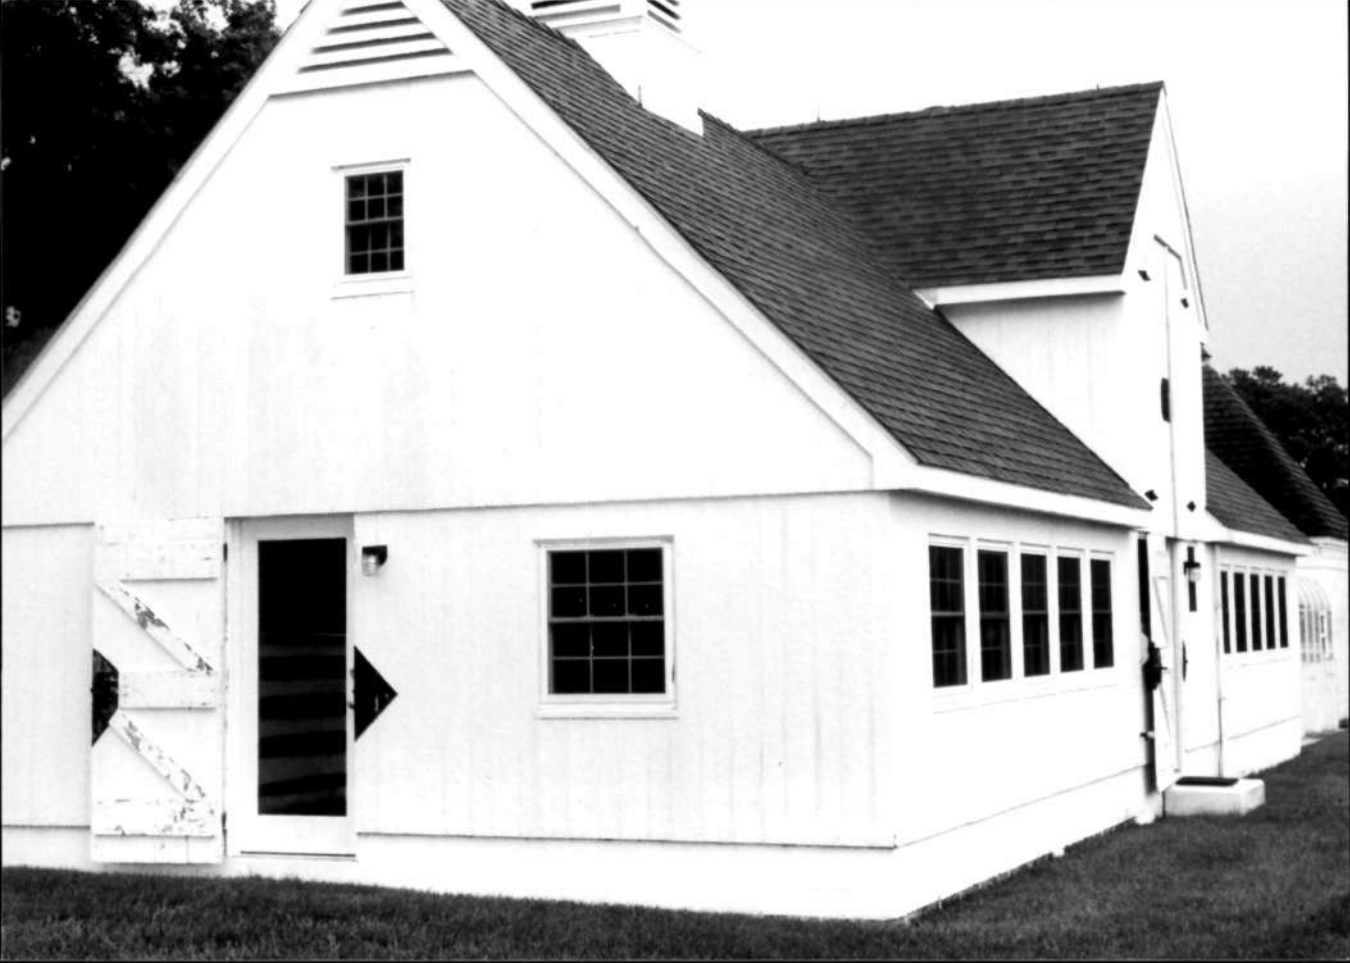
1/44

Chicken barn Lat'g E

The chicken house, constructed ca. 1930, is currently used as a recreation building. The building is a one-story light timber frame structure with a central passage single-pile plan. The building rests on a continuous concrete masonry unit foundation with a one-foot curb around the perimeter. The walls are clad with vertical wood planks. The cross-gable roof is clad with asphalt shingles and has two square cupolas and a projecting hayloft. The building is accessed through new French doors on the north and south façades. The window openings have been infilled with six-over-six vinyl sashes. The interior of the building is finished with drywall and has a poured concrete floor. A modern metal frame greenhouse is attached to the east façade.

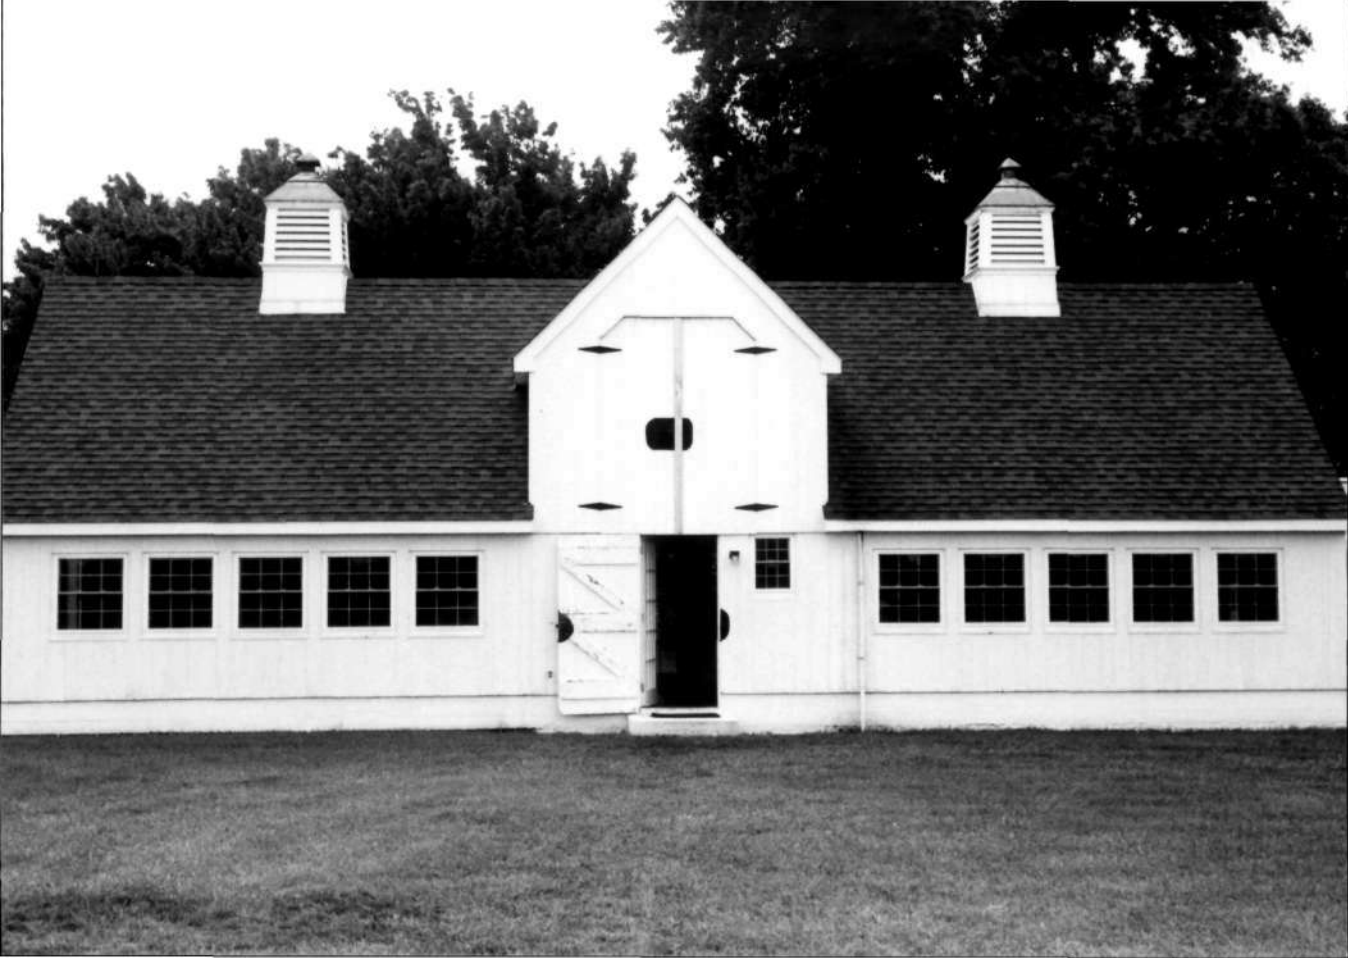
2/44

Chicken BARN (FRONT) Looking NE

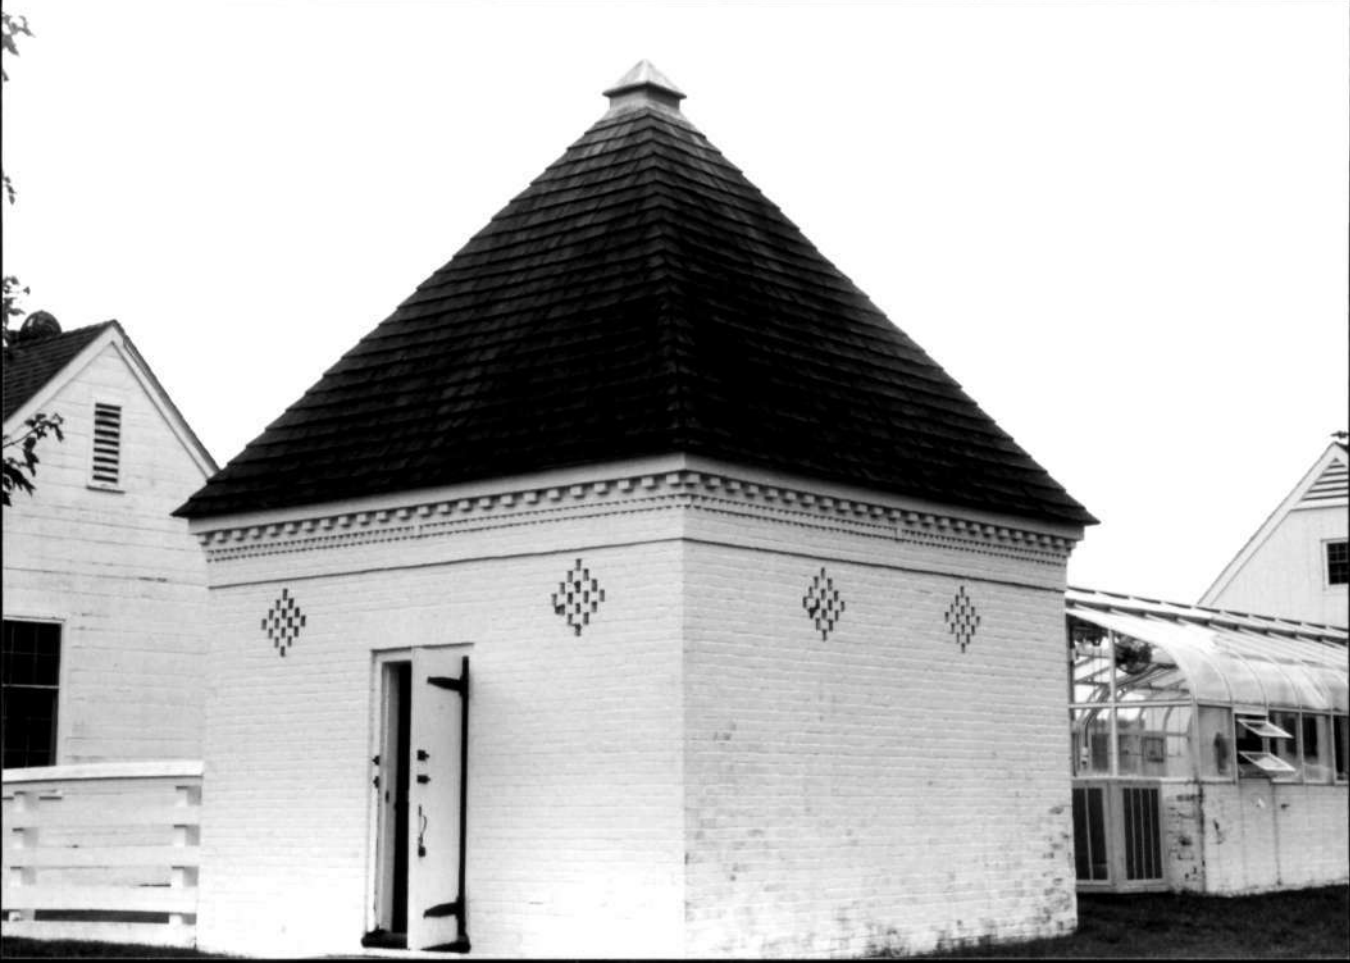
3/44

Smokehouse Lookg SW

The smokehouse, constructed ca. 1930, is currently used as a recreation building. The building is a one-story brick masonry structure with an undivided interior space. The building rests on a continuous brick foundation. The walls are constructed of brick using a Flemish bond and have vents worked into the brick pattern. The pyramidal roof is clad with wood shingles and has a metal ventilator. The building is accessed through a wood plank door on the east façade. The interior of the building is finished with a brick floor.

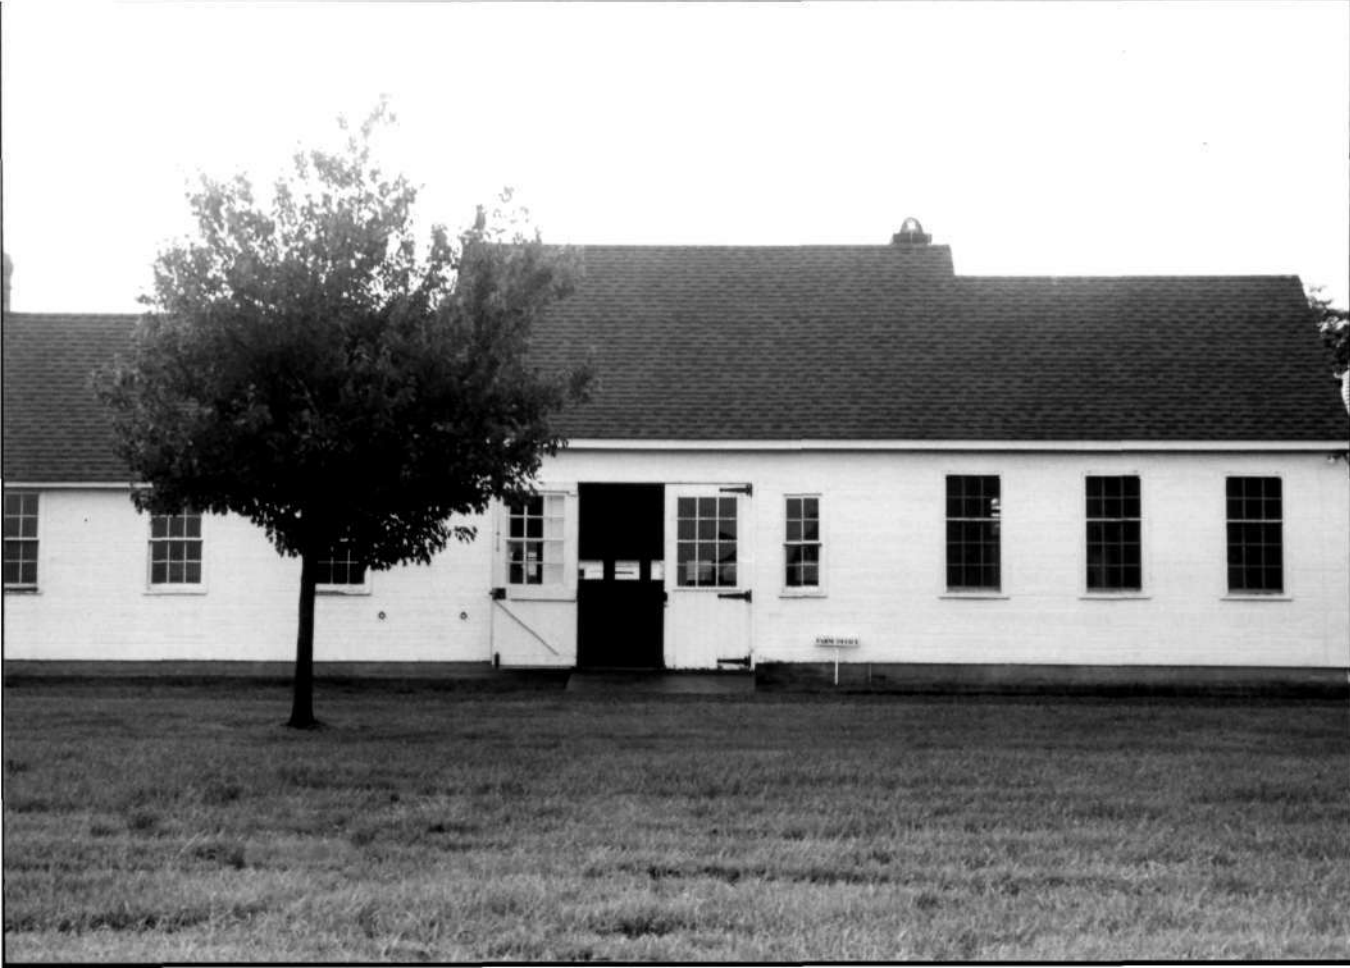
4/44

Office Looking W

The slaughterhouse, constructed ca. 1930, is currently used as an office and shop. The building is a one-story light timber frame structure with a three pen plan. The building rests on a continuous concrete masonry unit foundation. The walls are clad with horizontal wood siding. The side gable roof has a steep pitch and is clad with asphalt shingles. The building is accessed through hinged wood plank doors with twelve lights on all façades and metal roll up doors into the central pen.

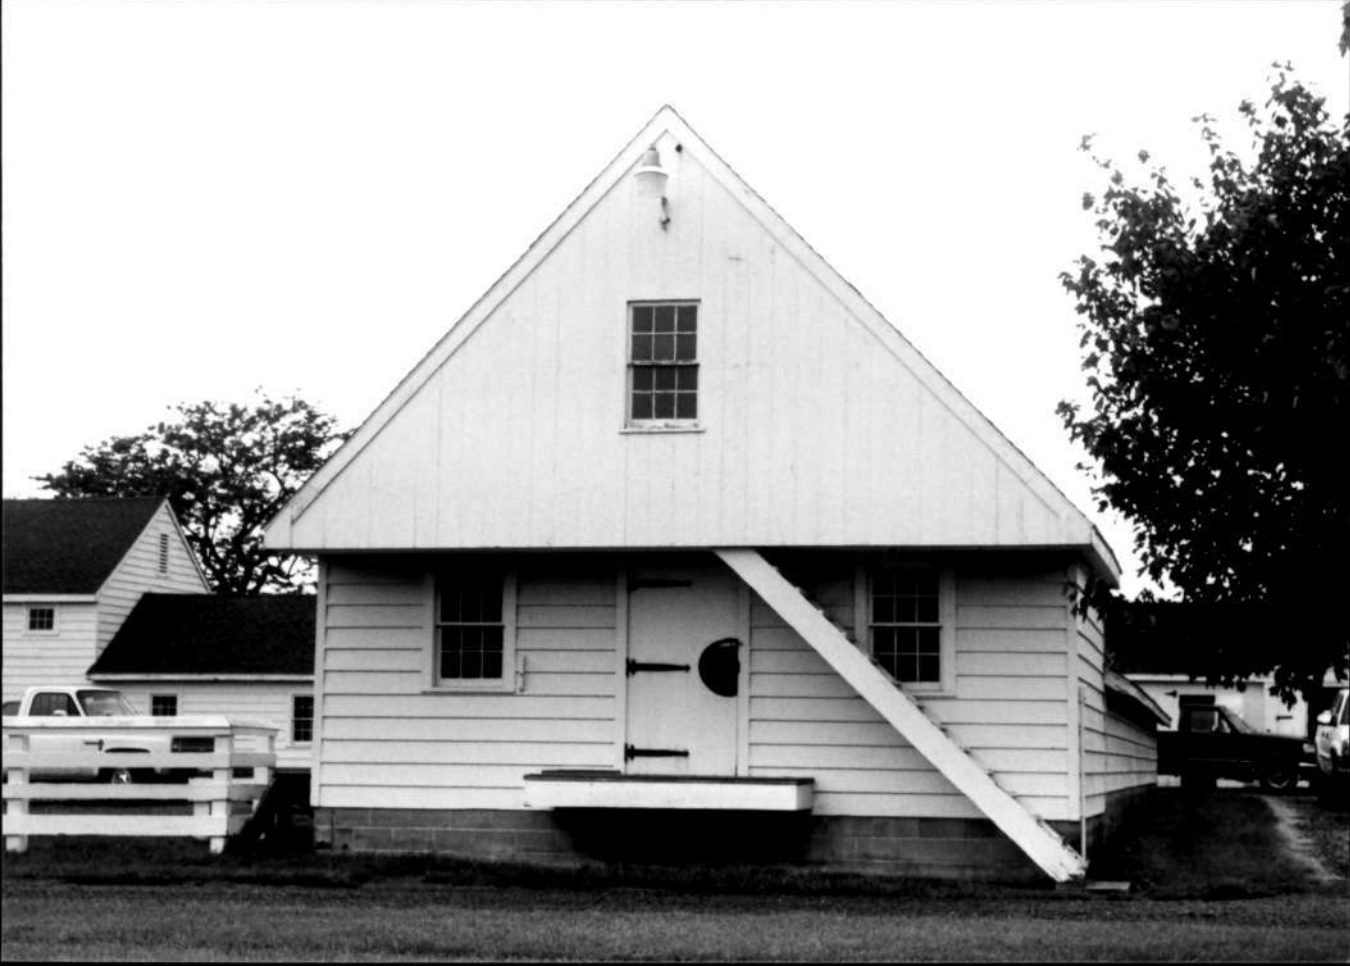
5/44

GRAINERY LOOK (W

The granary is a one-and-a-half story light timber frame structure with an undivided interior space. The building is accessed through two hinged wood plank Dutch doors with twelve lights on the east façade. The windows are six-over-six wood sashes and six-pane wood awning sashes. The interior of the building is unfinished and has a wood plank floor. Seven large raised wooden grain bins, two of which have been screened in, are located within the space.

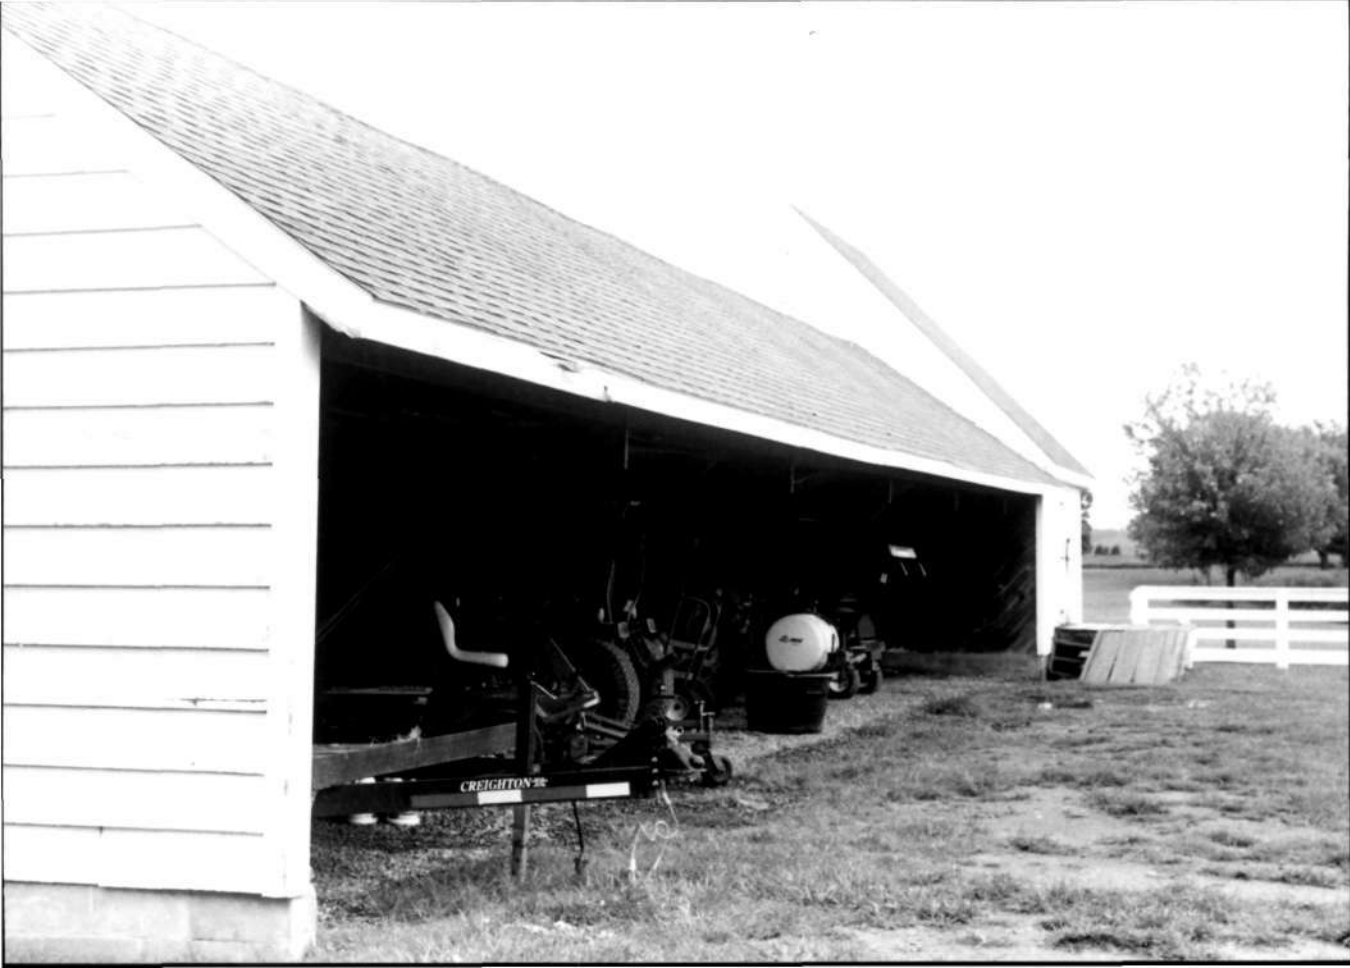
6/44

Machine Shed look E

A machinery shed is located on the west façade of the storage building. It is five bays wide and is of timber frame construction with an open south façade. The shed rests on a combination pier and continuous poured concrete foundation. The walls are clad with horizontal wood siding. The side gable roof is clad with asphalt shingles. There are no doors or windows. The interior of the building is unfinished with an earthen floor.

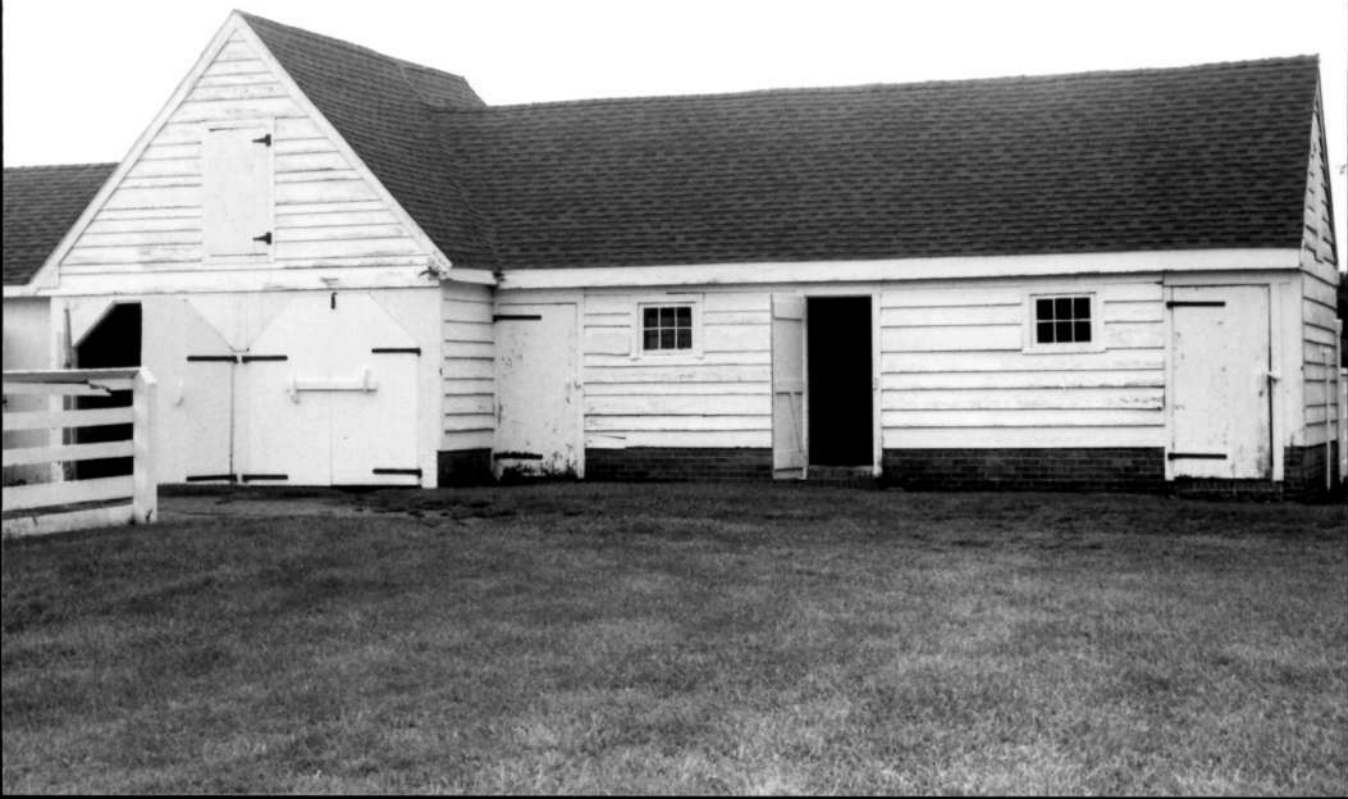
8/44

STABLE LOOK W

The stable is three bays wide and is of timber frame construction. There are no doors and the windows are six-over-six wood sashes. The interior of the building is unfinished with an earthen floor. Eight wooden animal pens with feed troughs are located within the space.

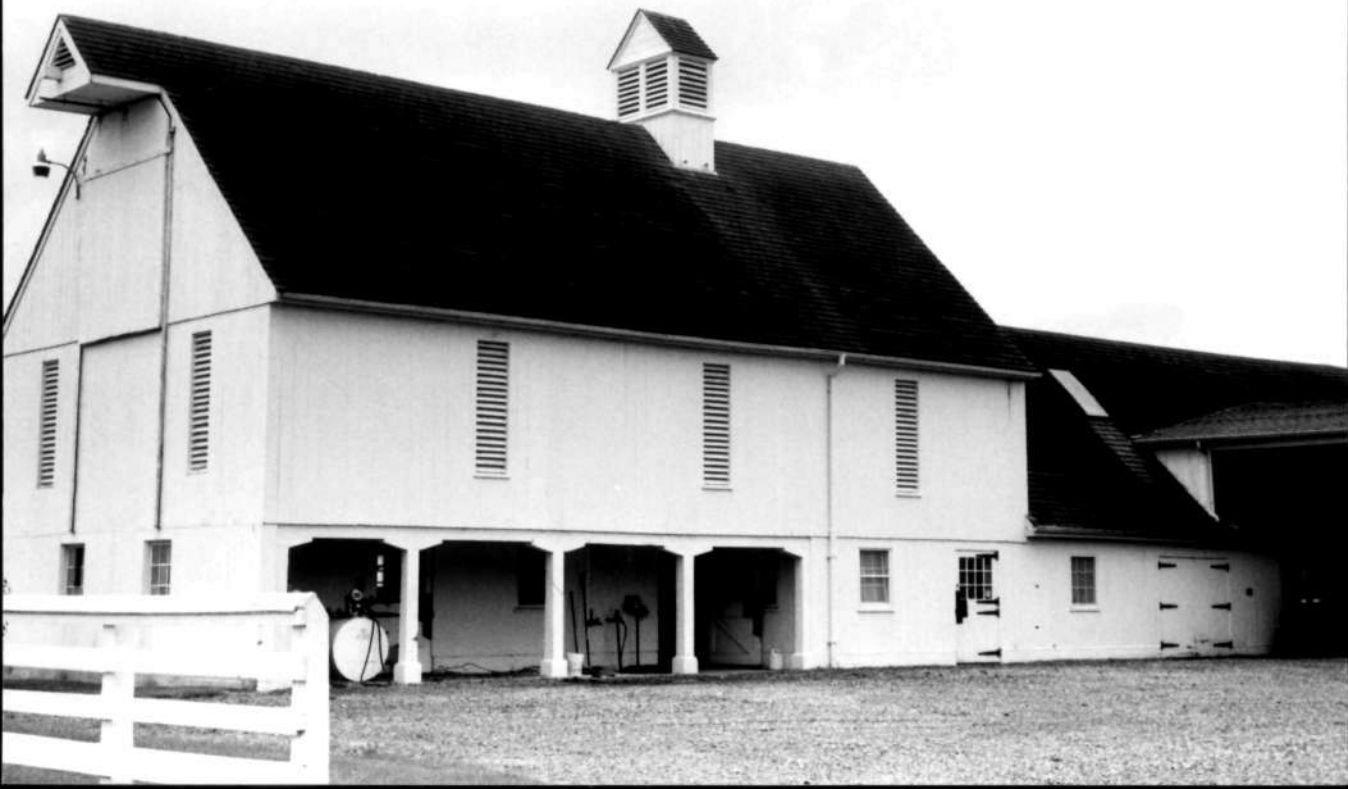
9/44

BARN Look SW

The corncrib connects to the multi-purpose barn, constructed ca. 1939, with a rear animal pen addition. The building was significantly altered when a new access road was constructed to the east of the barn. The length of the building was shortened by 15 feet to 30 feet and the roof was replaced. The structure rests on a continuous concrete masonry unit foundation. The timber frame structure is clad with vertical wood siding. The front-gable roof is clad with asphalt shingles. The barn has a hay hood on the east gable end. The Dutch doors are hinged wood plank with diagonal bracing and twelve lights. Sliding wood plank doors are located on the gable ends. The windows are nine-pane wood hopper sashes. The interior of the building is unfinished with a poured concrete floor and metal animal pens.

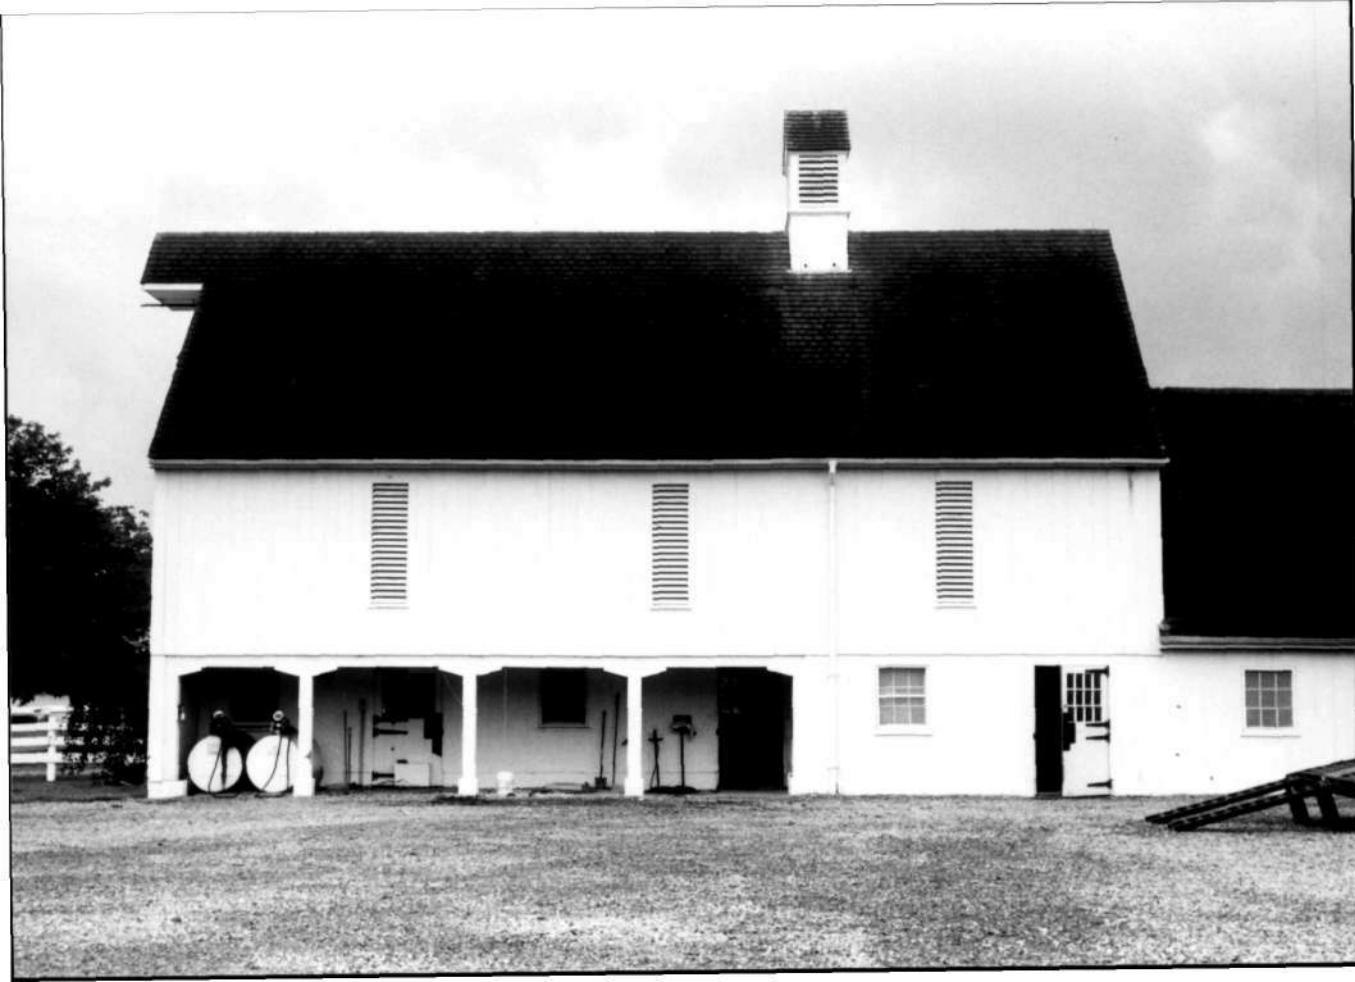
10/44

BARN LOOKING S

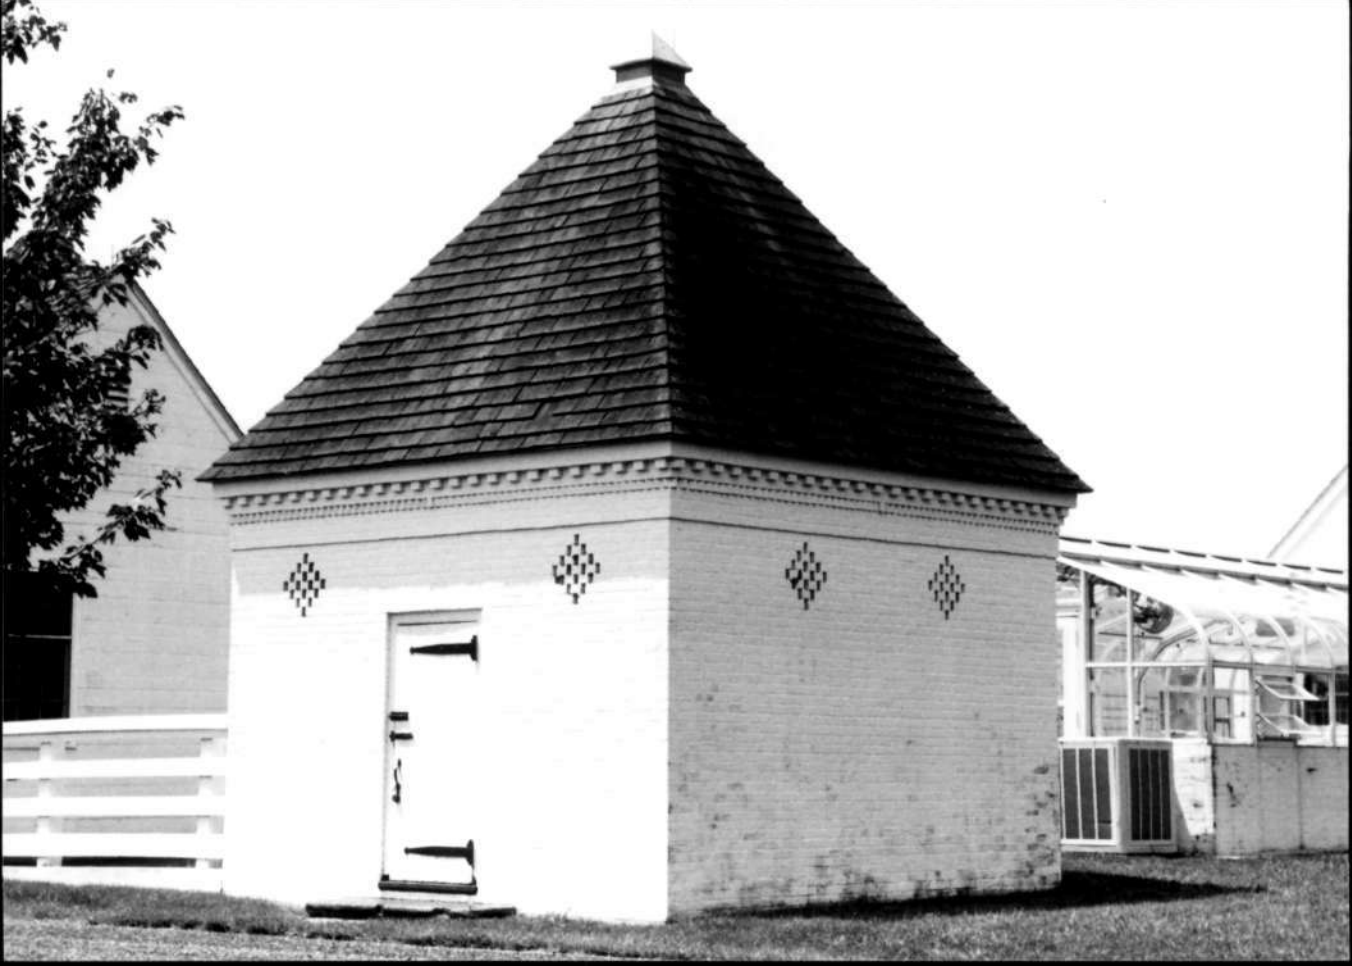
18/44

Smokehouse Looking W

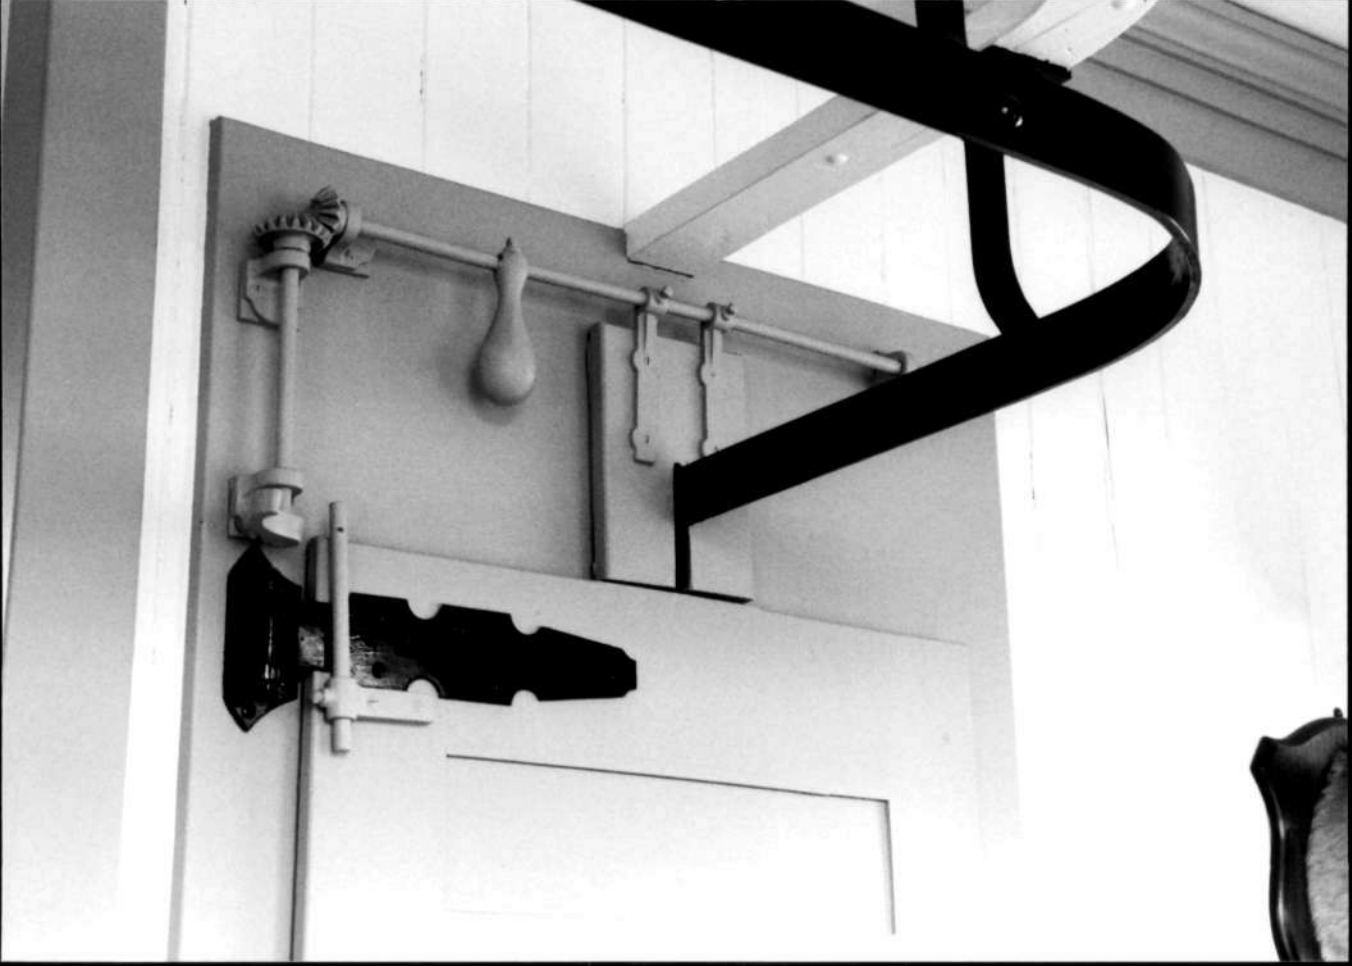
19/44

MEAT SAFE door mechanism detail

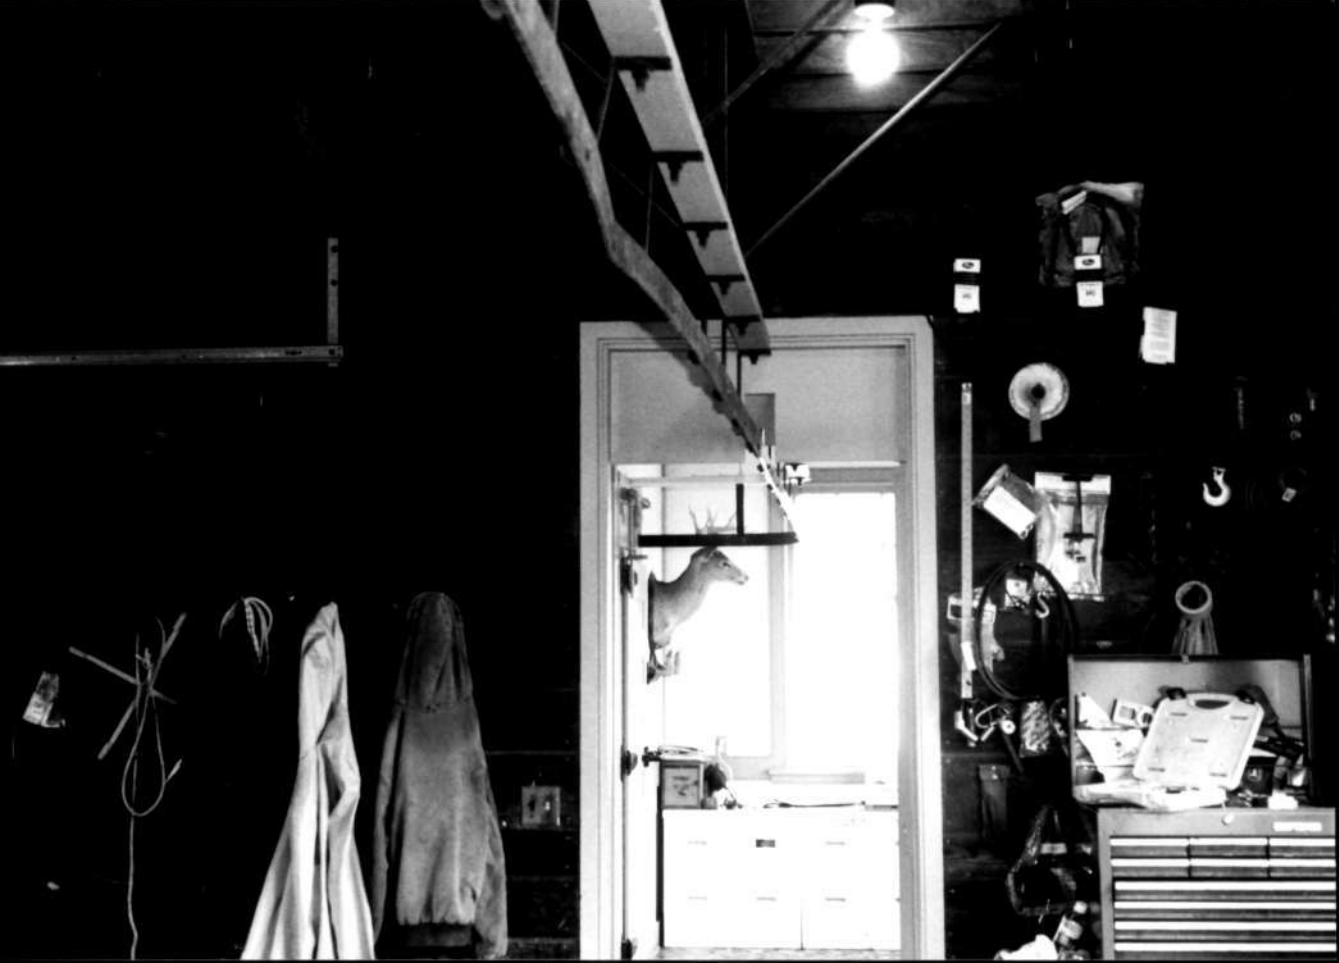
20/44

MEAT RAIL + OFFICE RAFTERS

The interior of the building contains the original steel rail that allows the meat to be slid from the slaughterhouse floor into a cooler located in the northwest corner of the office. The meat locker is clad in vertical wood siding and has a three inches thick door. A mechanism lifts a wood flap above the door allowing the hook to slide freely when the meat locker door is opened approximately 130 degrees. The meat locker was manufactured by the Bernard Gloekler Company, which was located at 1627-1633 Penn Avenue in Pittsburgh, Pennsylvania.

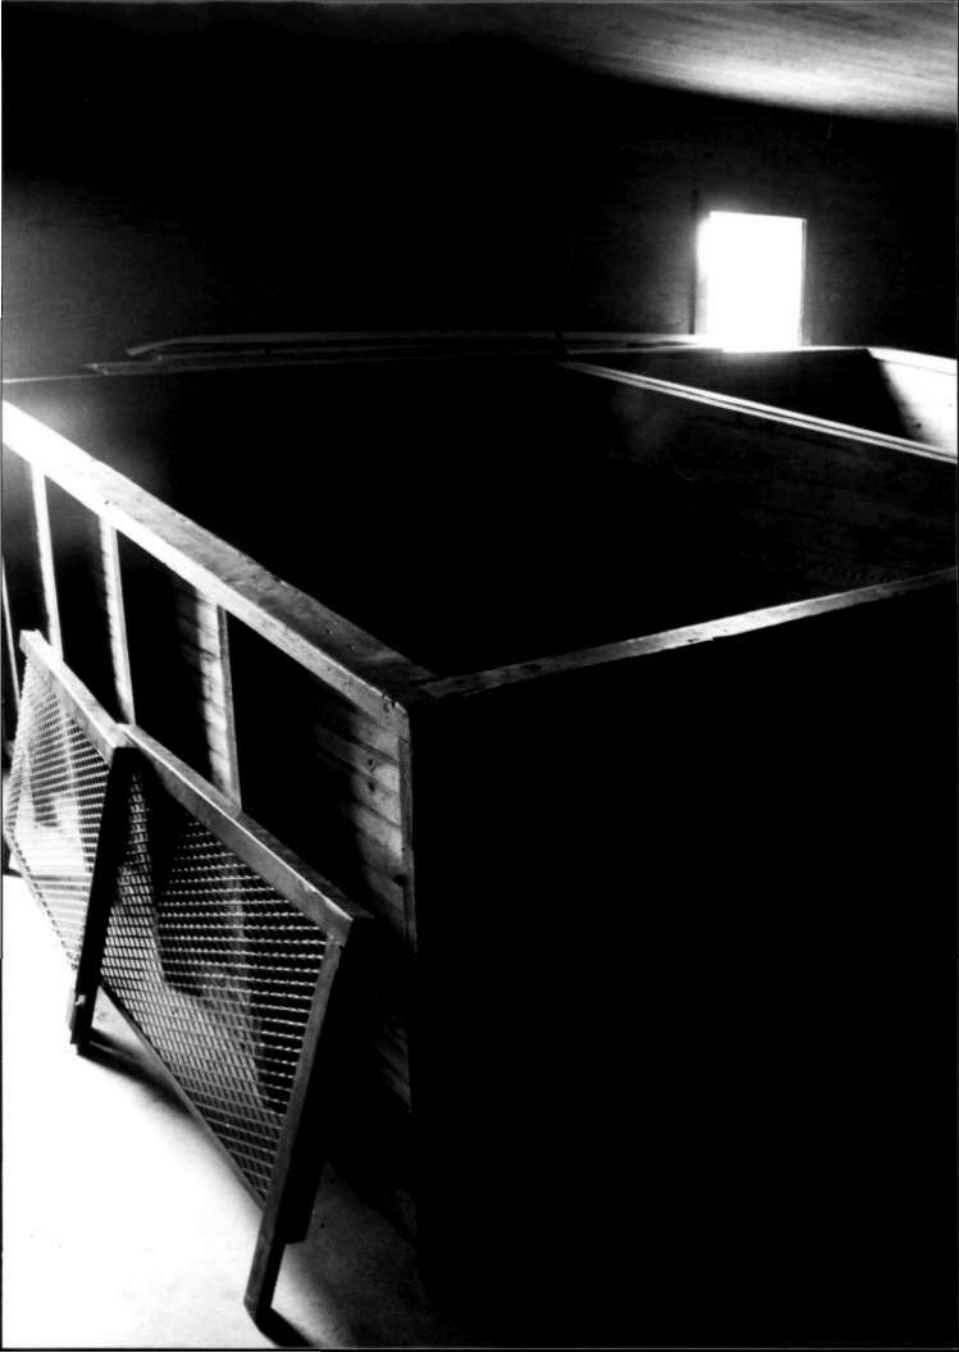
29/
44

GRANARY bin detail Look SE

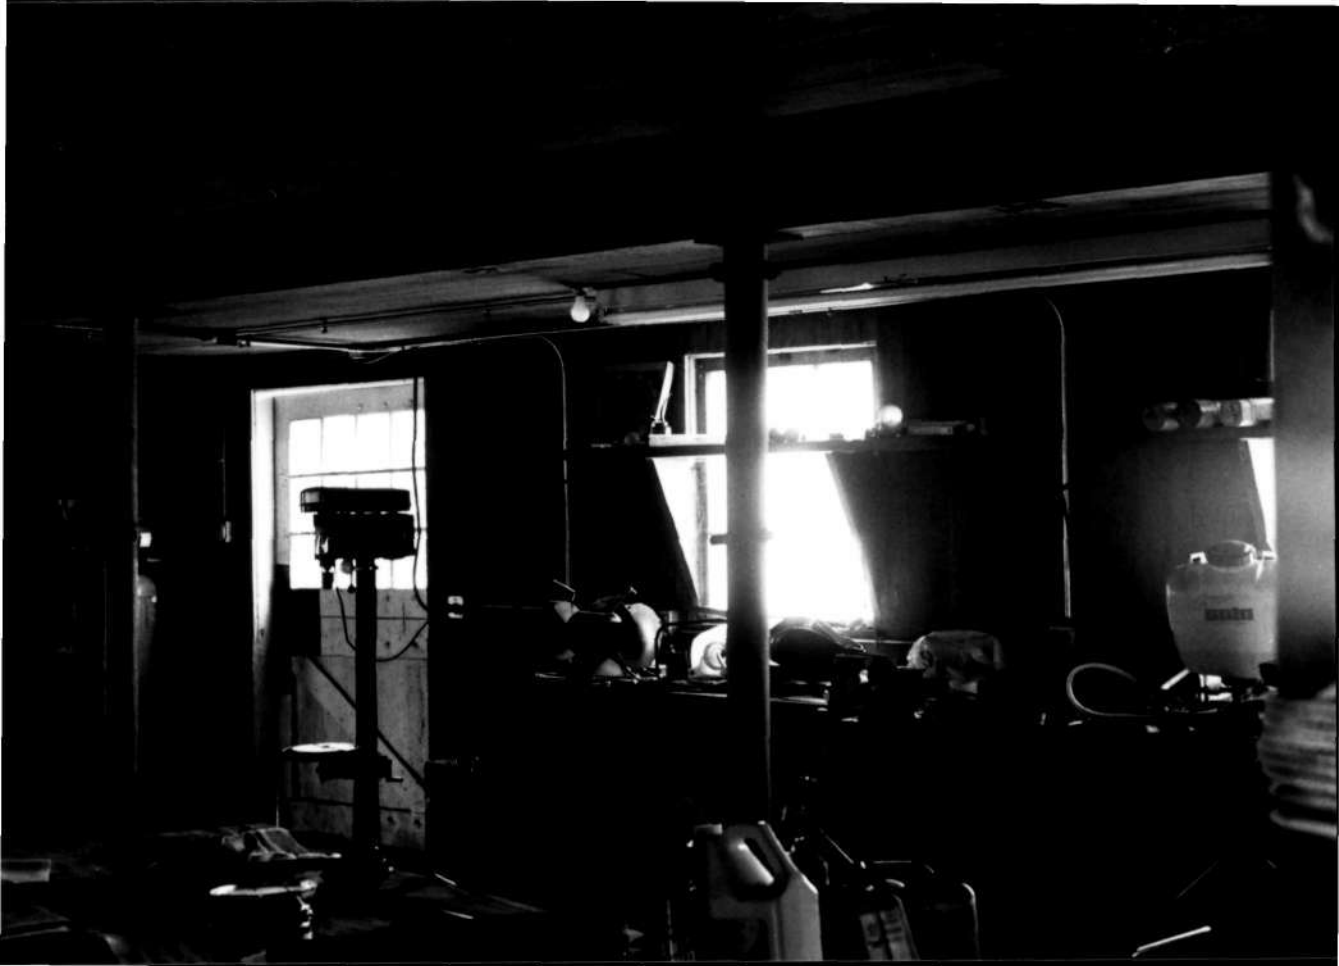
30/44

BARN INTERIOR LWS S
